# Quality, Health, Safety, Security & Environment Bulletin (QHSSE)

MARFLET MARINE S.A.

# INDEX:

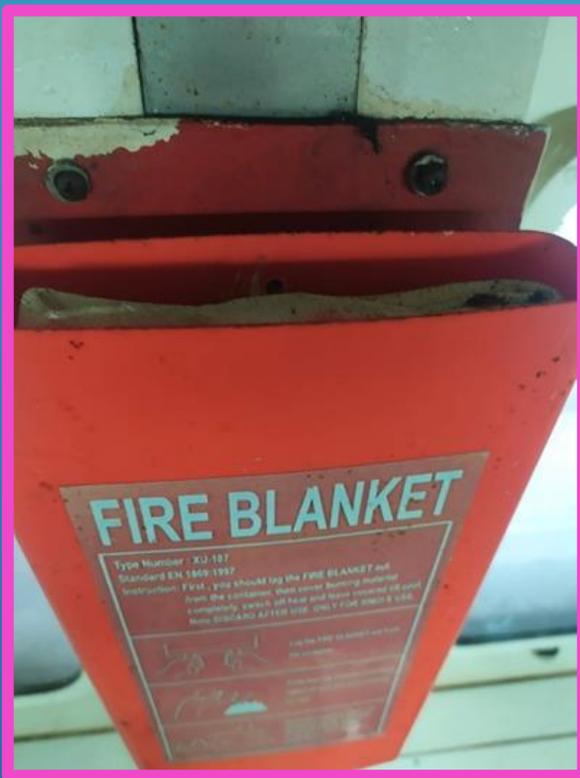
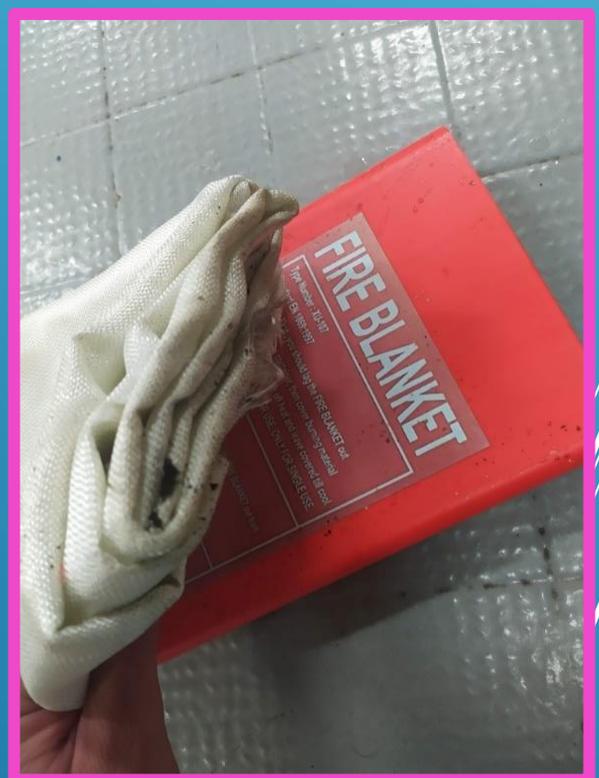
During the firefighting checking routines (14,0 Fire Blanket Monthly Inspection) according to FFE instruction with 2<sup>nd</sup> Officer A, was found the following condition from the FB.

The Fire Blanket located in the galley (close to the stove) was stowed in its correct position. This element is not expired and it is in its own package and ready to use but because it is close to the stove all the vapor from cooking during the time, was depositing grease on it. This type of material can absorb grease and oil becoming dangerous in case of fire.

From my own experience I know that using a greasy blanket to extinguish a fire it is counterproductive because the blanket becomes flammable.

So, my proposal is the next: for this model, cover the top part of the FB packaging with a non-flammable material protector such as a aluminum.

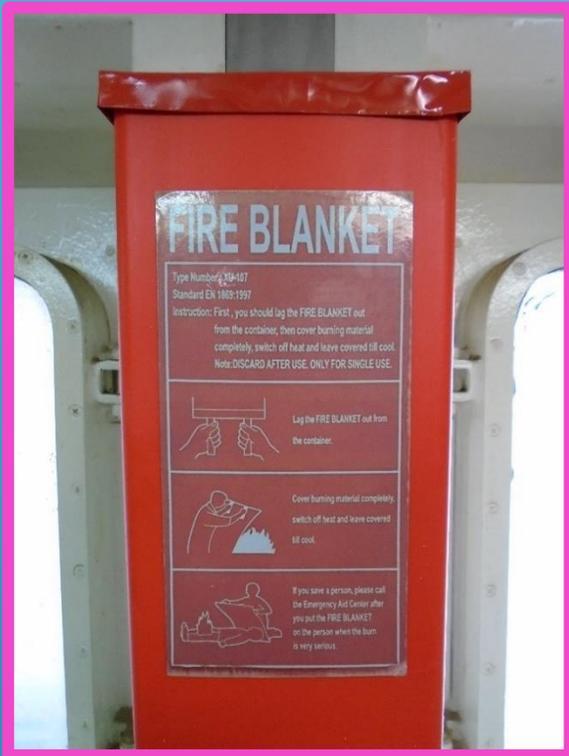
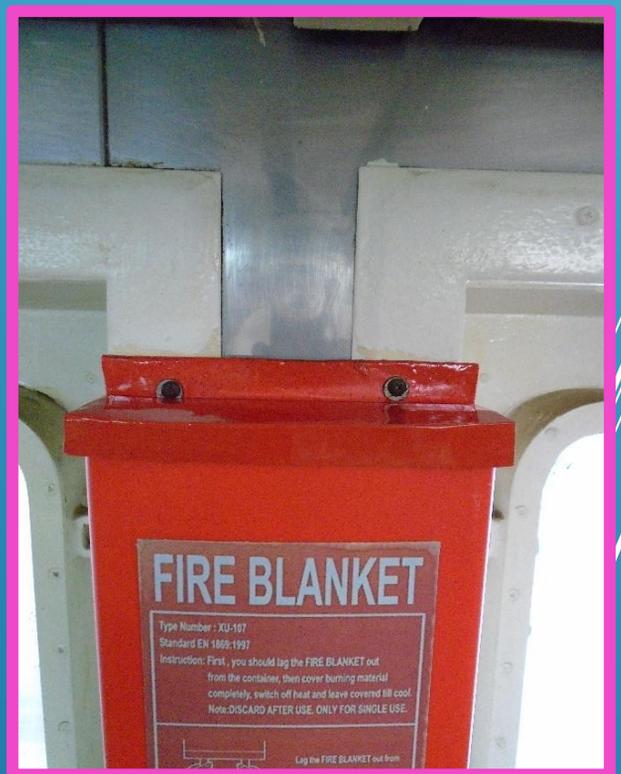
I made this protector with aluminum from a soda can. It is easy to make, it is not flammable and avoids the accumulation of grease in the Fb from cooking activities.

Taking this simple action will protect the FB, and it Will be in excellent conditions and ready to be use without extra danger.

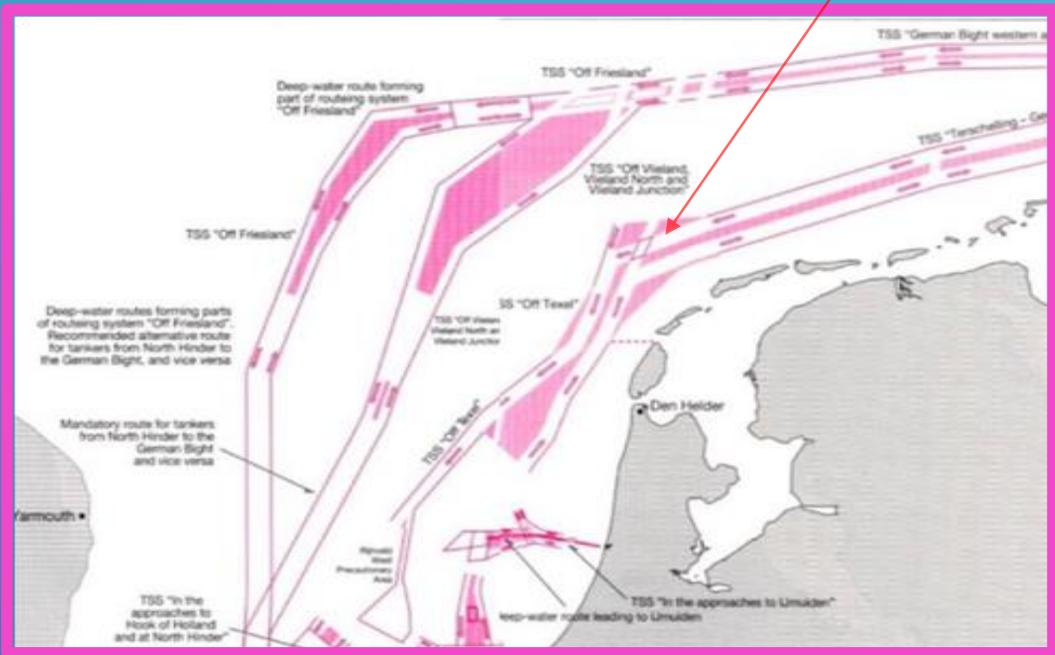
Violation Area - TSS VLIELAND

On 23 august 2022, one of our managed tankers in laden condition, carrying a cargo of Gasoline from Klaipeda was identify by the Netherland Coast Guard navigating in Position: 53-38.6' N; 004-41.1' E southbound, heading towards her next port of call Amsterdam, NL.

Netherland Coast Guard informed that this action constitutes a violation of routeing measures for tankers according to IMO resolution “Mandatory route for tankers from North Hinder to German Bight and vise versa”, since the vessel did not comply with the mandatory tanker route.

As a result, an official report was issued by the Dutch National Police – Maritime Division, and a fine of € 5,500 was issued to the Master so as to reach an off-court settle-ment and avoid the Master’s prosecution by local authorities.
