30th June 2025

Quality, Health, Safety, Security & Environment Bulletin (QHSSE)

Q2/ 2025

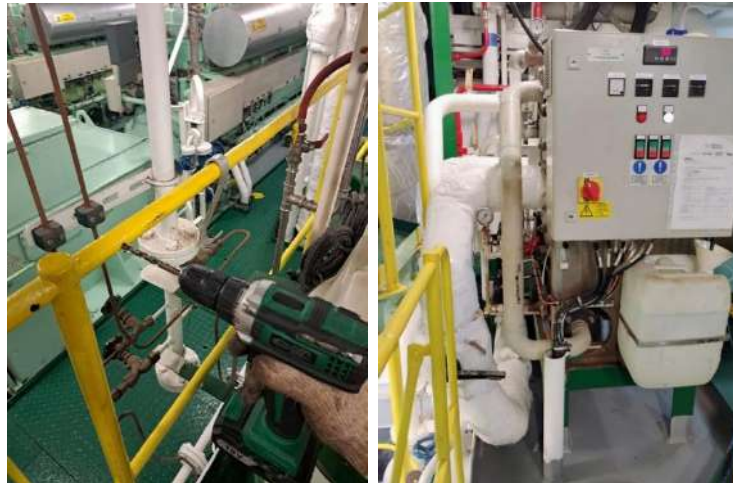
BEFORE

Since this ship was delivered from shipyard and how many years pass by, I noticed this point of Chemical Dosing tank of Fresh generator and Boilers doesn't have Standby Proper PPE on the sides and during adding some chemicals it is easy to find and to use the PPE and it must have always visible when it comes of Inspection and to avoid deficiency from the inspector, as per MSDS those chemical for dosing tanks has Hazardous contain it can easily injured if someone does not use proper PPE. In this case we plan to fabricate a box besides of Fresh water Generator and Boilers chemical dosing tanks to Store the proper PPE and always standby in case someone will use it and for the future inspection.

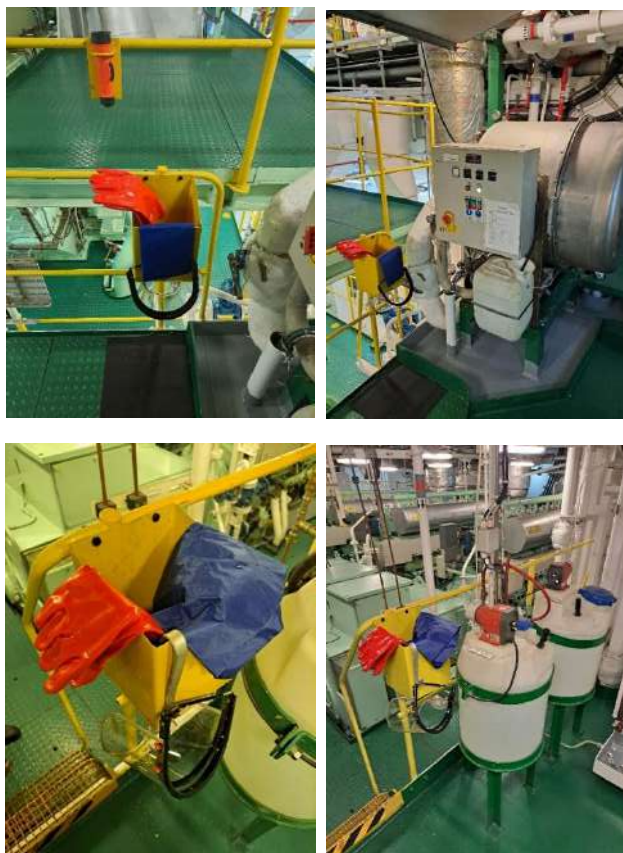
AFTER

This BEST PRACTICE is when you fill up the chemical dosing tanks, it is easy to see & use the Chemical PPE and it's safe for everyone.

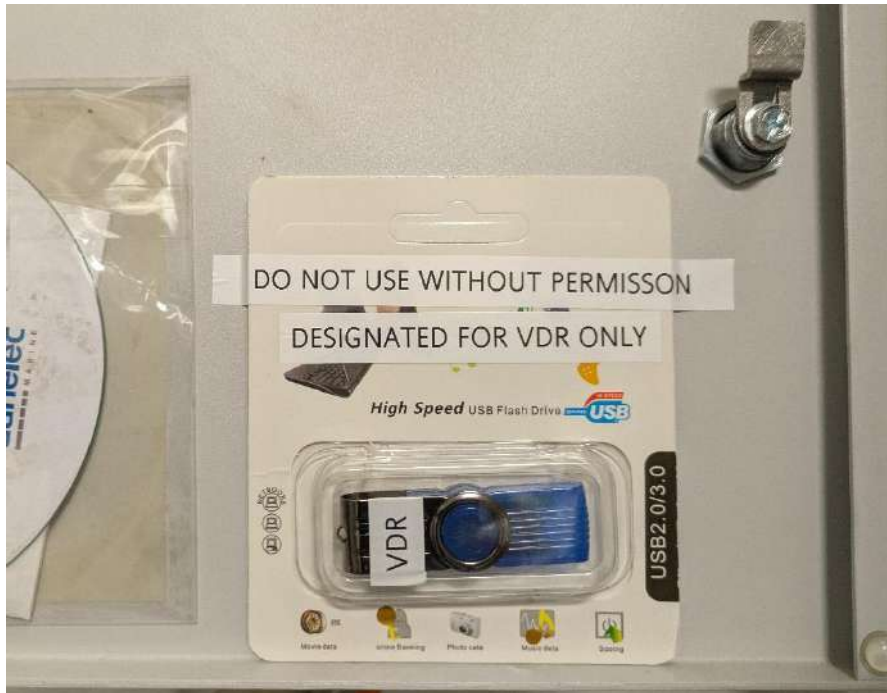
In case of emergency or incident where we need to extract data from VDR system, we should have an adequate USB Memory stick available on board with enough capacity of memory to be able to extract all recorded data, designated only for this matter. This USB Stick must be always under Master supervision and not to be used without Master order/permission.

To avoid any delay/problem for this simple issue during urgent scenario, USB stick has been placed in the vicinity of VDR system, into Gyro and Navigation equipment room. Extraction instructions have been clearly posted as well.

Designated USB must have enough capacity to record all data, and crew should know this limitation. *In the case of 'MT Santiago I' for 48 hours of recorded data, the system is extracting 28-33 GB. If the designated USB is not adequate to cover all this memory, an alert will rise in the VDR Alarm Panel, and we will not be able to extract it. So, it is necessary at least 64 GB USB memory Stick.*

Only specific crew should know the location and procedure to avoid any cybersecurity problem, under Master supervision.

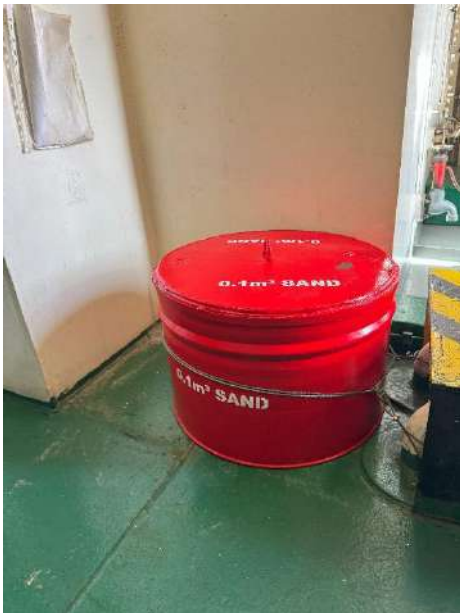
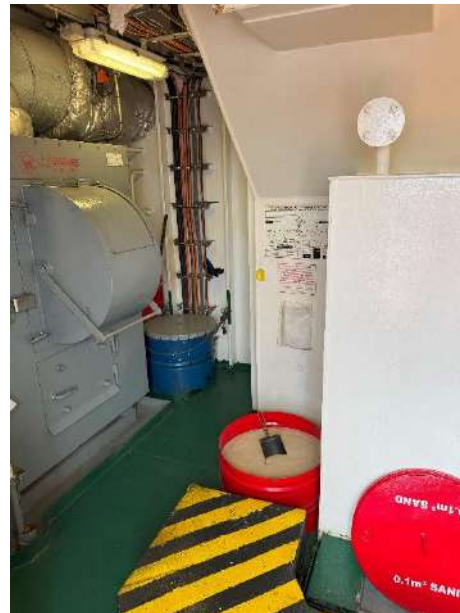
The incinerator room is classified as a machinery space of category A containing oil-fired boiler (SOLAS II-2/3.31), so as per SOLAS Regulation 10, Chapter II-2, paragraph 5.1.2.3:

In each firing space there shall be a receptacle containing at least 0.1m³ sand, sawdust impregnated with soda, or other approved dry material, along with a suitable shovel for spreading the material. An approved portable extinguisher may be substituted as an alternative.

Currently, our incinerator room is already equipped with two portable fire extinguisher that meets the necessary approval standards. However, in the interest of enhancing onboard safety and ensuring full compliance with the aforementioned SOLAS regulation, I have taken the additional step of placing a dedicated receptacle filled with 0.1 m³ of sand within the firing space. This supplementary measure is intended to further reinforce our fire safety preparedness and provide an additional means of manual fire suppression, thereby contributing to a safer working environment for all personnel.

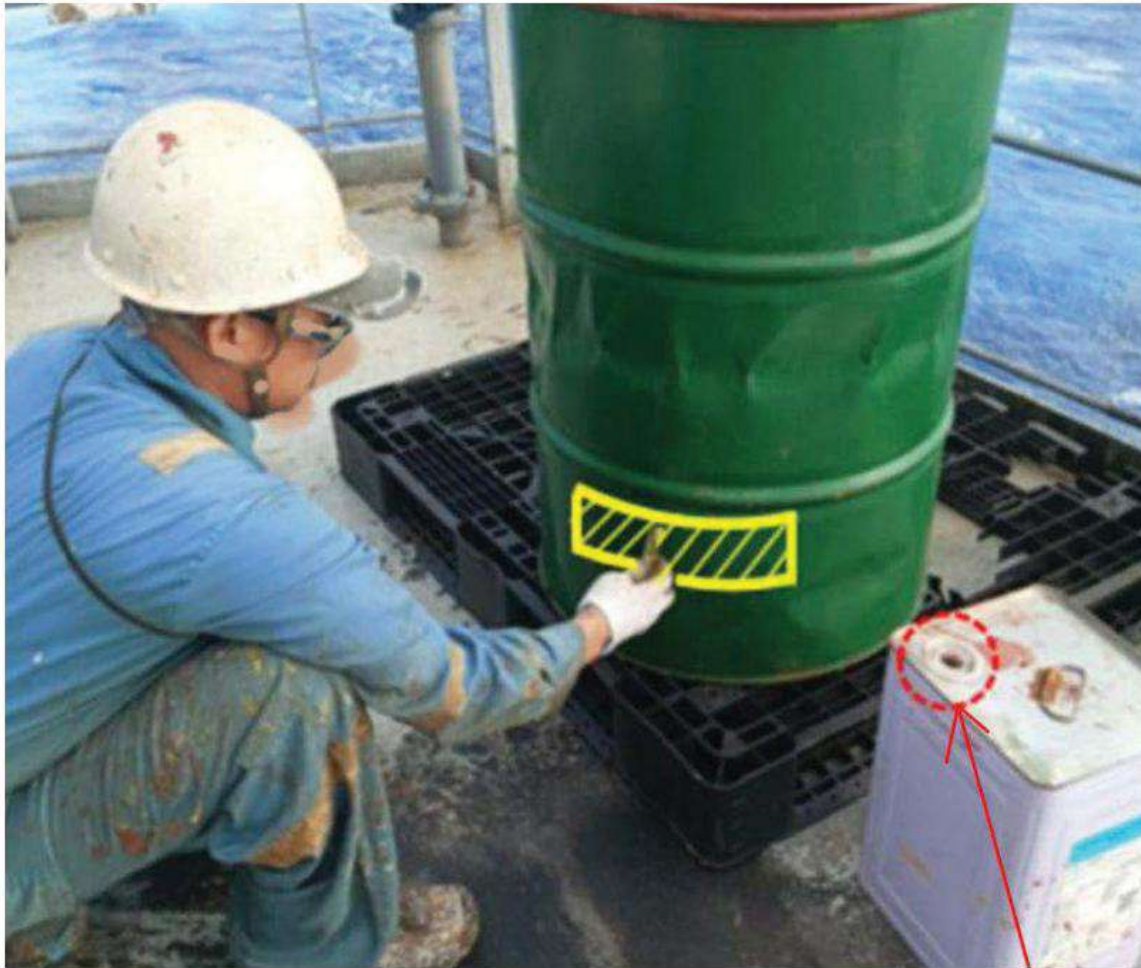
A deck crew member was assigned to dispose of accumulated shipboard plastic waste by burning it in an empty 200-litre oil drum on the poop deck, using only wastepaper as an accelerant. Over the course of the morning, he burned several bags of plastic waste and resumed the task after lunch.

At approximately 1420, an explosion occurred, triggering the fire alarm and alerting the crew. The crew member was found engulfed in flames. His colleagues extinguished the fire and transferred him to the ship's hospital. Despite receiving medical assistance and evacuation efforts, the crew member later died from his injuries.

The investigation identified critical failures in communication and procedure. The Master intended for the plastic waste to be landed ashore, but this was not communicated to all officers. The Chief Engineer denied a request to use the incinerator without explanation, prompting the Chief Mate to improvise by instructing the burning of waste on deck—a practice not permitted by the Company's SMS. Crew members followed these instructions despite knowing they violated company procedures.

Reconstruction: note yellow rectangle showing access hole and open can of paint thinner

- **Never burn any material on open decks.** Waste should be disposed of in the vessel's incinerator or stored for shore disposal if the incinerator is unavailable.
- **Strict adherence to SMS and ISM procedures is essential.** Gaps between written procedures and actual practices can lead to serious incidents.
- **Effective communication and leadership are critical.** Vessel leaders must set the standard and ensure all crew members are informed and empowered to challenge unsafe practices.
- **Safety culture requires vigilance.** Crew should question any instruction that appears unsafe or non-compliant.

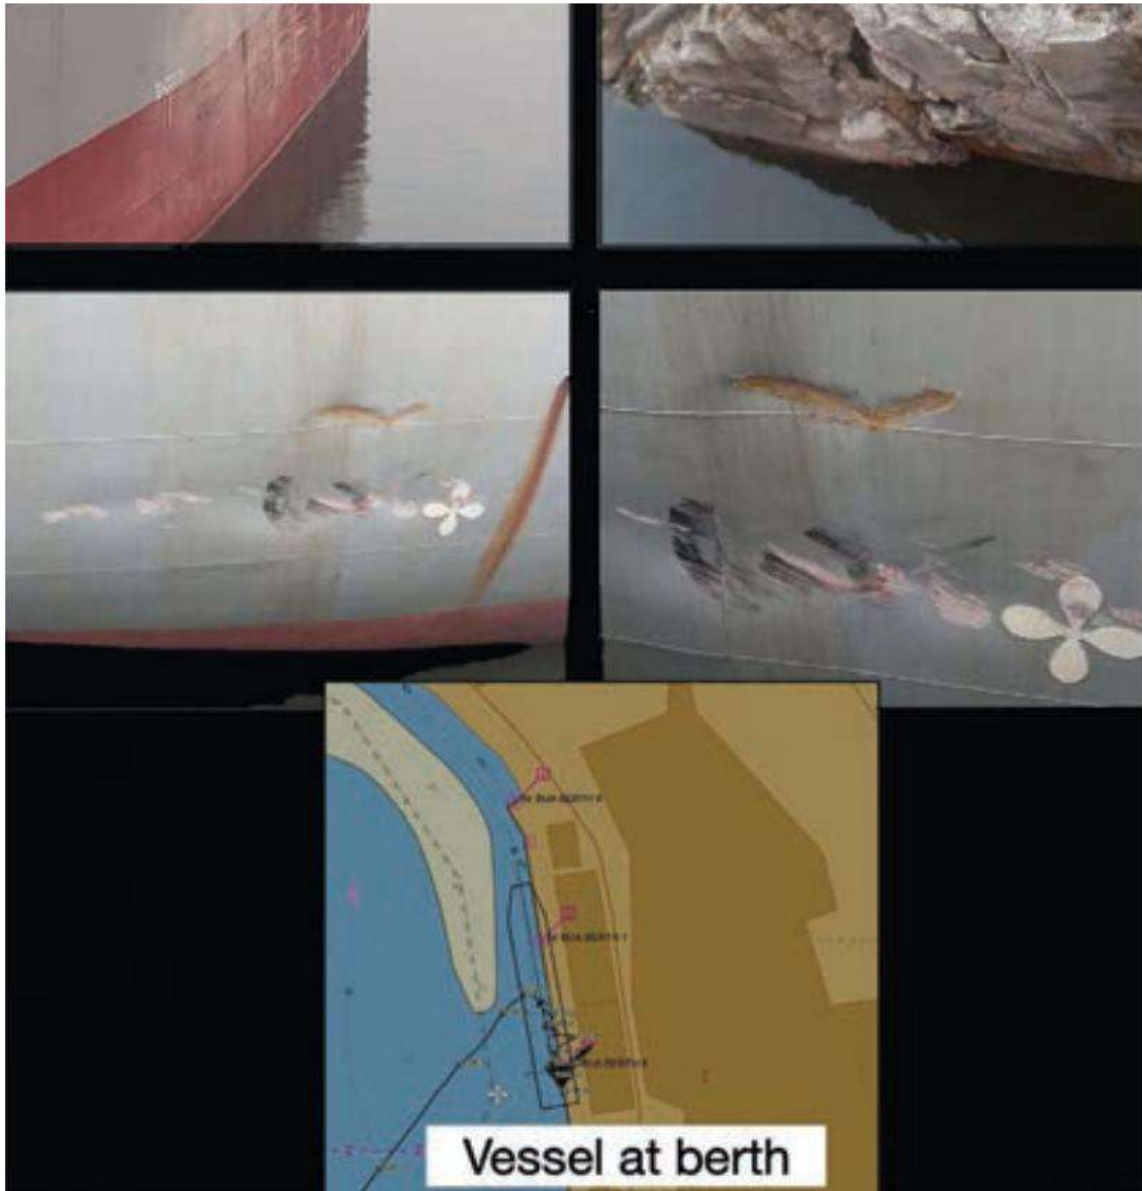
A cargo vessel, under pilotage and with tug assistance, was berthing in a confined waterway characterized by strong currents and shallow waters. The complexity of the operation was heightened by local regulations prohibiting tugs from securing lines to the vessel, restricting their role to push-assist manoeuvres only.

During the approach to the berth, the vessel was making 4.8 knots before corrective actions were initiated. Despite several engine manoeuvres and the eventual deployment of the port anchor, the vessel made contact with the pier at a speed of 0.9 knots. Damage was sustained to both the starboard bow and the aft starboard quarter.

A company investigation determined that the incident resulted from a combination of environmental, operational, and systemic factors. The strong currents and shallow waters significantly hampered the vessel's manoeuvrability and exacerbated the challenges posed by the angular design of the pier. These environmental factors were further complicated by local regulations, which limited tugs to push-assist operations and prevented them from providing pull support.

Critical communication gaps were identified between the vessel's bridge team, the pilot, and the tug operators. Furthermore, the delayed deployment of the port anchor reduced its effectiveness in countering the vessel's swing to starboard during the final phase of the approach.

- **Comprehensive pre-berthing planning and preparation are essential** to mitigate operational risks in challenging environments.
- **Open and continuous communication** between the Master, pilot, and tug operators is crucial for effectively managing the dynamic conditions encountered during berthing operations.
- **Regular drills and training focused on emergency response procedures**, including timely anchor deployment and adaptive manoeuvring, are vital to ensure that crews are adequately prepared for similar scenarios in the future.
