# Quality, Health, Safety, Security & Environment Bulletin (QHSSE)

MARFLET MARINE S.A.

# INDEX:

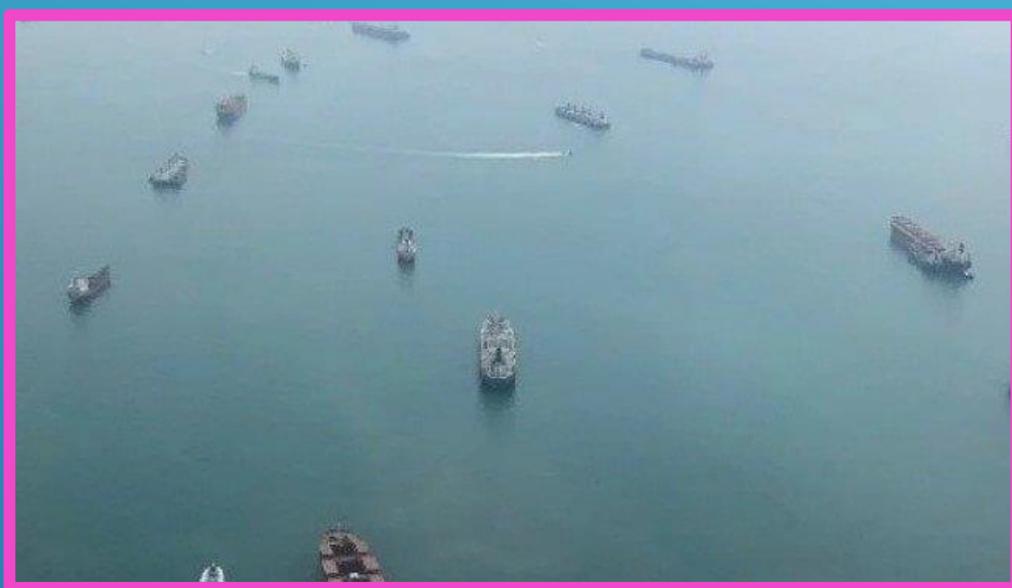
Singapore Strait remain the area of highest concern for robbery of ships underway in the eastern traffic lane

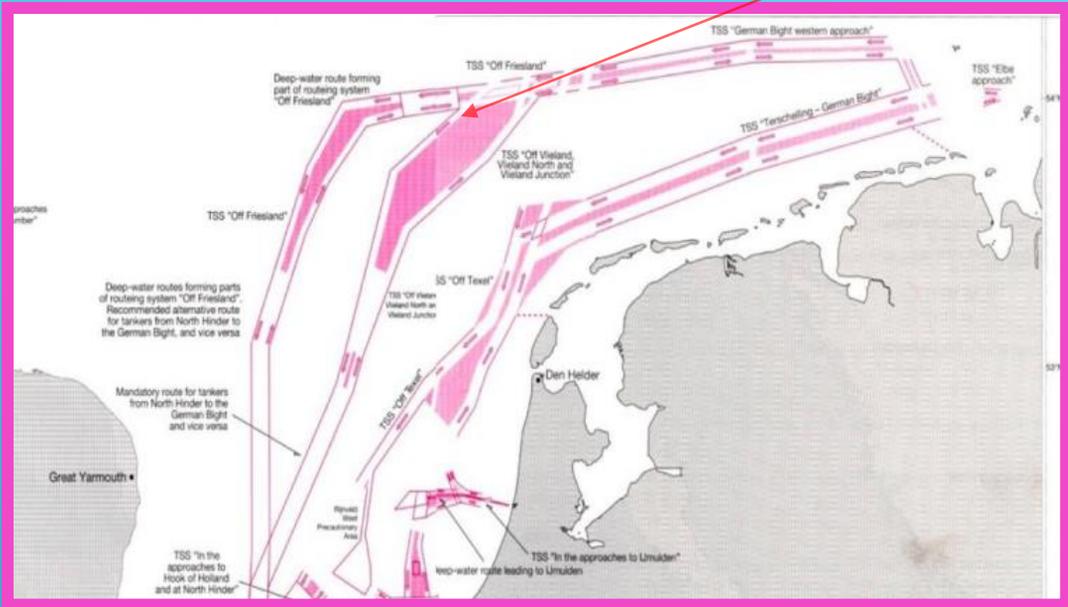
Mandatory Routes for Tankers from North Hinder to the German Bight and vice versa

Netherland Coast Guard informed that this action constitutes a violation of routeing measures for tankers according to IMO resolution “Mandatory route for tankers from North Hinder to German Bight and vise versa”, since the vessel did not comply with the mandatory tanker route.

Violation Area - TSS VLIELAND
