30th June 2025

Quality, Health, Safety, Security & Environment Bulletin (QHSSE)

Q2/ 2025

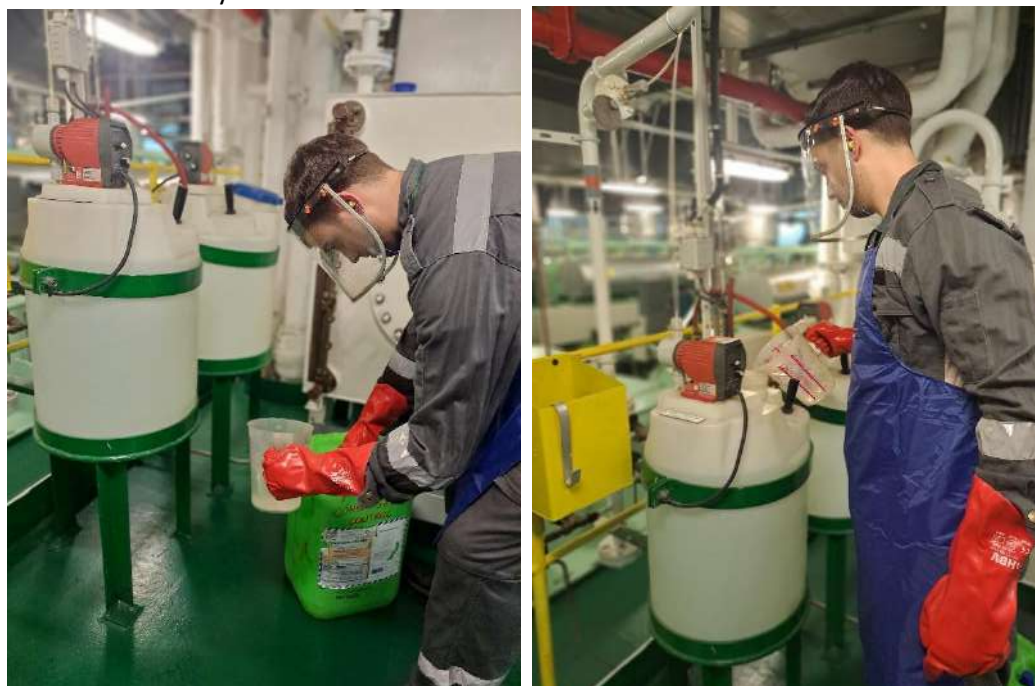
This BEST PRACTICE is when you fill up the chemical dosing tanks, it is easy to see & use the Chemical PPE and it's safe for everyone.
